Public Power Corporation
Steam Electric Station - UNIT IV
Megalopolis GREECE

**PUBLIC POWER CORPORATION
SES MEGALOPOLIS UNIT IV
GREECE**

Problem occurred during the maintenance of **Feed-water pump No.3** (suction pressure 15 bar and discharge pressure 250bar) at Unit 4 of Steam Electric Station located in Megalopolis Greece.

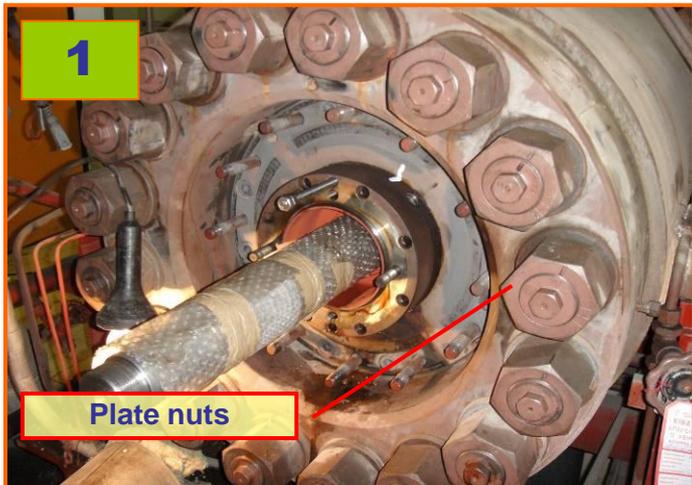
Pic.1 Plate with holding nuts

The extraction of the main plate nuts from the discharge side of the pump deteriorate the studs threads.

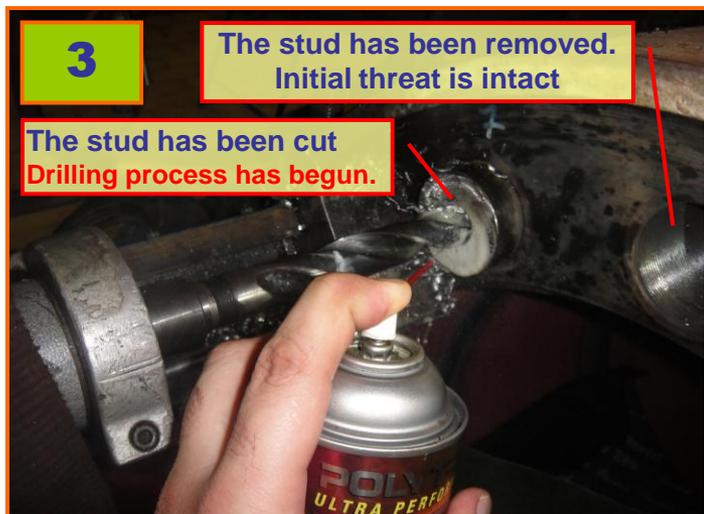
Pic.3 Polytron PL been spayed

Technicians who were aware of the effectiveness of Polytron products suggested the use of the company's spray for this difficult process.

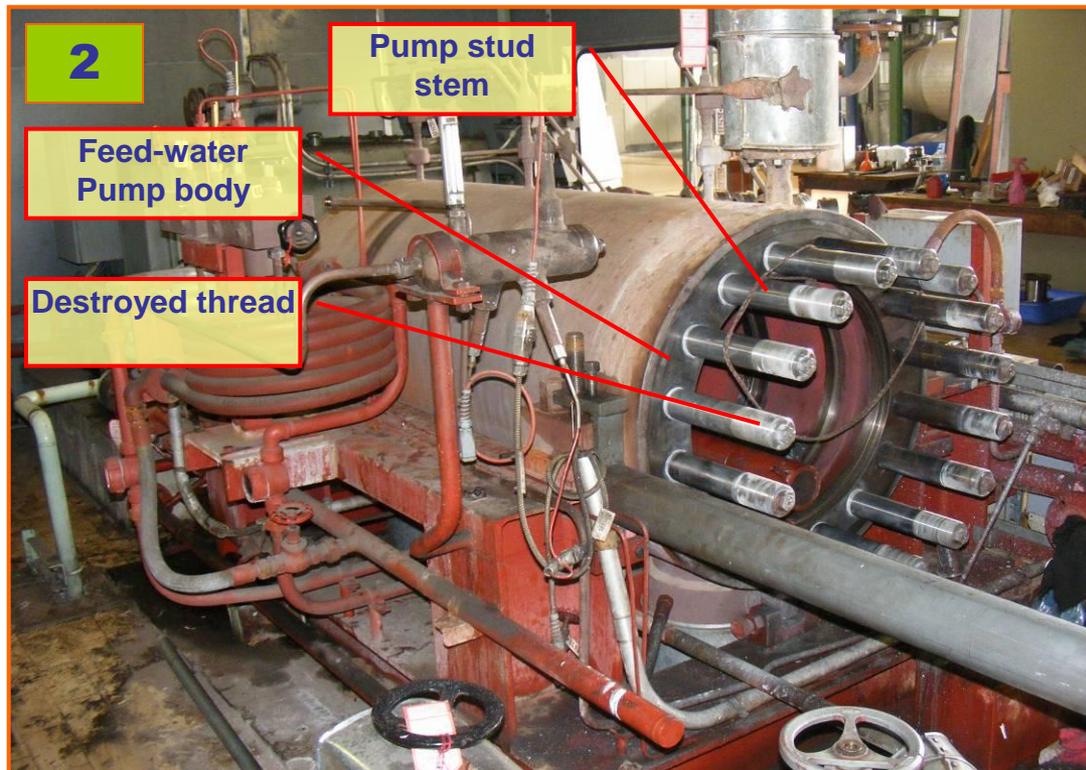
Since threads of severe studs were destroyed, it was necessary for them to be cut away and removed from the pump body.

Pic.2 Main plate studs, some must be removed.

More specifically, some of the studs stems were cut and the threaded ends remaining in the water pump body. They were then drilled over and over with increasing size drill.

This procedure was carefully repeated until all the material belonging to the stud end was removed.

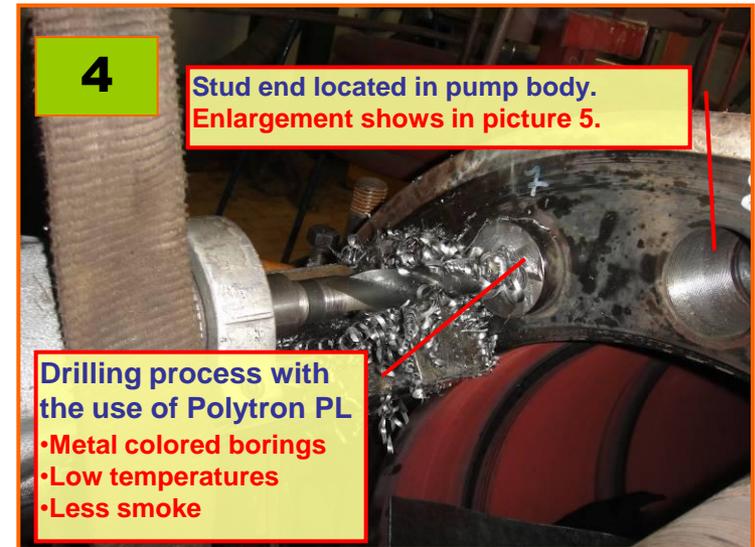
The drilling of stud ends was difficult because the studs were made of hardened steel **20NiCrMo145 Din 1.6772**. This is why well know penetrating spray were used during the drilling process.

During the drilling process though problems occurred with overheating, the creation of rough surfaces, smoke and blue colored borings.

Pic.4 Drilling process with the use of Polytron PL

The use of Polytron PL made the drilling procedure unobstructed, quicker, more efficient and solve the problem of overheating. The drilling borings had become metal-colored and the surfaces that had been drilled were much smoother.

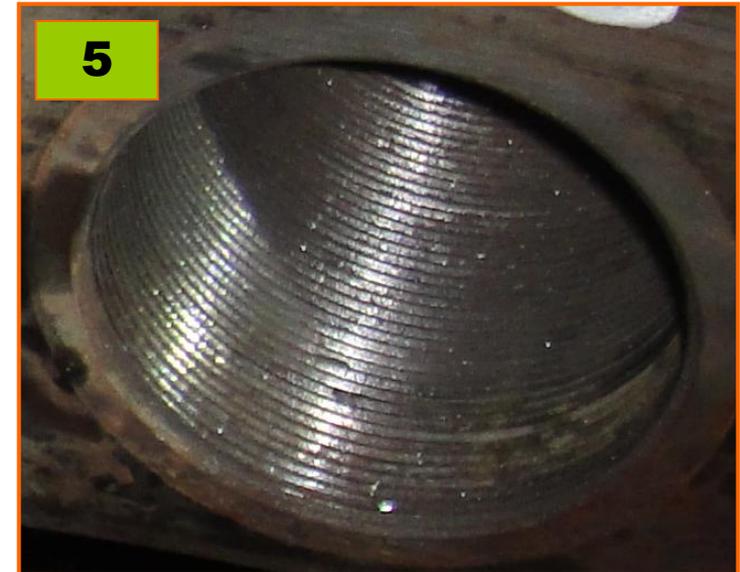
Pic.5 Threading belonging to the pump body after the removal of the stud ends

This was necessary to protect the original threads (see picture 5) of the pump body in order for the new studs to be successfully bolted in place.
